Lack of Brick Maintenance

This is an Example of a Brick Building with Multiple Problems

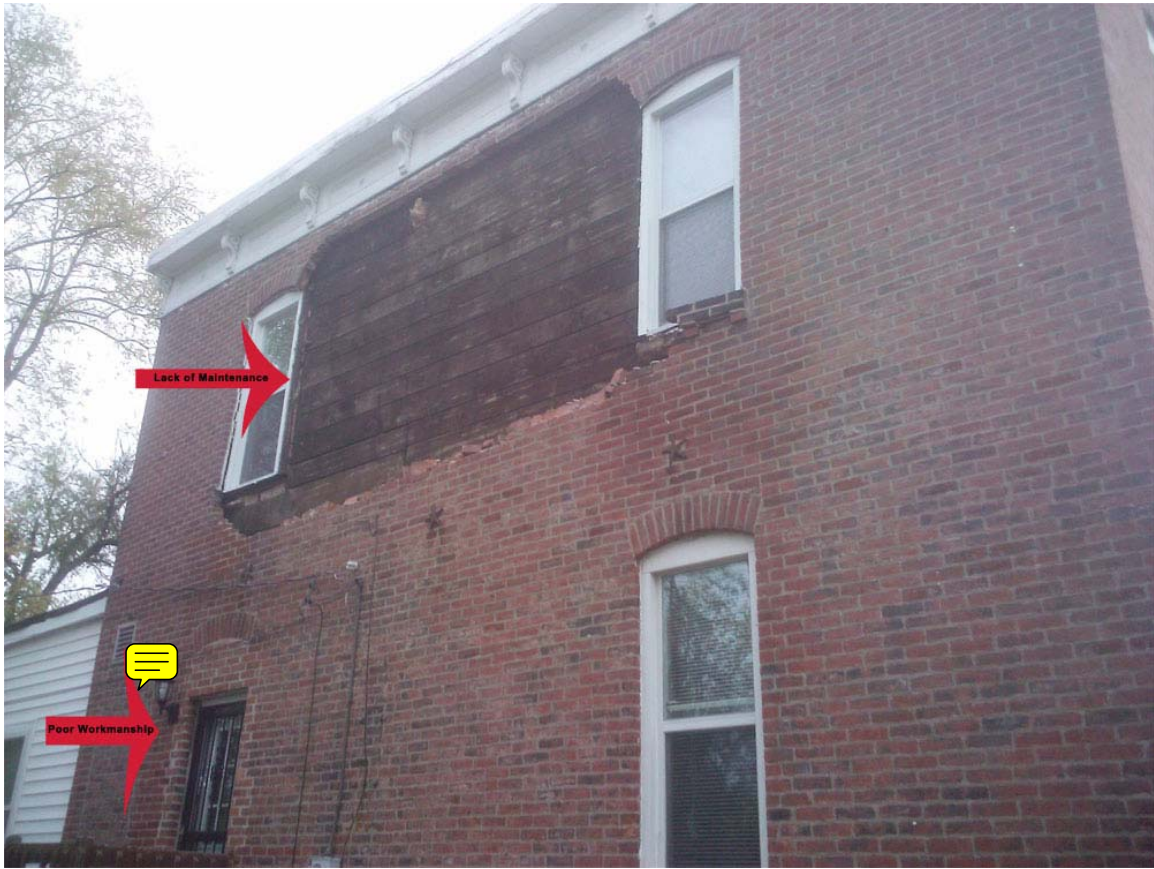
This brick building has had a lack of brick maintenance (tuckpointing), which will be more costly to repair now. By letting a building get in this condition there is a good chance that there will be damaged wood behind the brick that may have to be replaced because of it constantly being moist do to water seepage through the mortar joints and there could be structural damage to your wood studs, also there will most likely be damaged brick because of the fall to the ground, which will have to be replaced. Don't put off having your building tuckpointed or it may end up looking like this. Also notice the side door entrance that used to be a window. The contractor did a poor color match tuckpointing job. This contractor's workmanship shows a lack of pride in their work. Don't be fooled by "Fly by Night Contractors".
